## Comparative Tests on Roofs with Photovoltaic Systems

### CEI - TS 82-89 - ANPE - Istituto Giordano

## Large-Scale Experimental Test – ANPE - Istituto Giordano

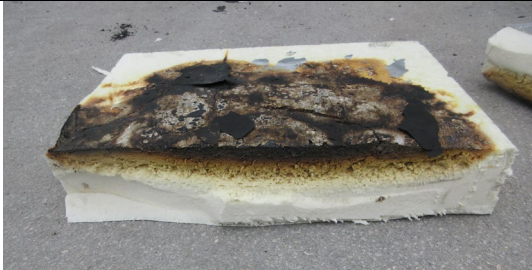
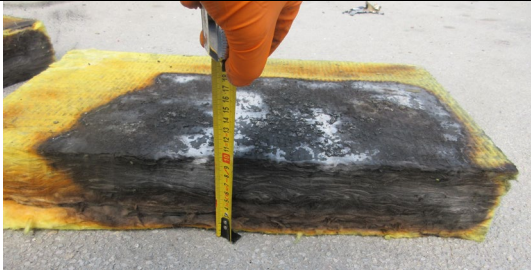
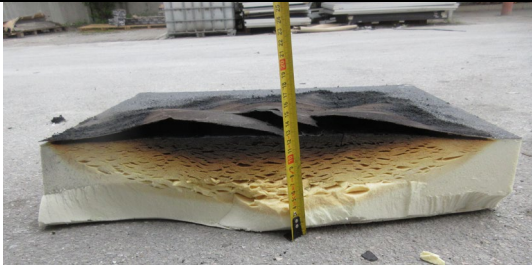
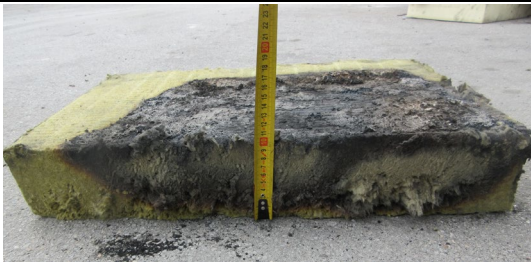
*Degree of penetration of the fire on the thickness*

<p>PU E</p>	<p>MW Glass A2 s1 d0</p>

<p>PU B s1 d0</p>	<p>MW Rock A1</p>

- Roofing systems classified as B<sub>roof</sub> (t2) showed similar damaged areas, limited to those areas affected by falling burning debris from the photovoltaic panels. In no case did the damage reach the outer perimeter of the sample.
- The classification system placed all four samples in Class C, regardless of the fire of the insulation material.
- The photovoltaic panel tested on a non-combustible support (calcium silicate) received a B classification, though it was close to the limit for that category.
- Heat release rate curves showed similar trends, with minor differences in growth rate and total extinction time.
- Fire penetration into the insulation material varied significantly:
  - PU samples showed only surface charring.
  - MW samples experienced damage throughout their entire thickness.
  - Glass wool samples exhibited a thickness reduction of approximately 20 mm.

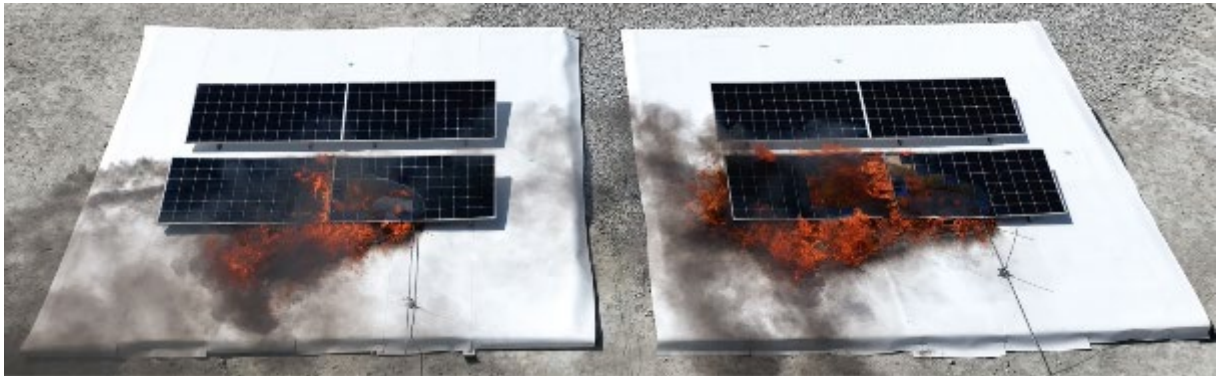
*Test configuration*

Two roof samples measuring 6 m × 6 m were built, and both were tested simultaneously to avoid different weather conditions, wind direction and speed, to allow to compare the results directly.

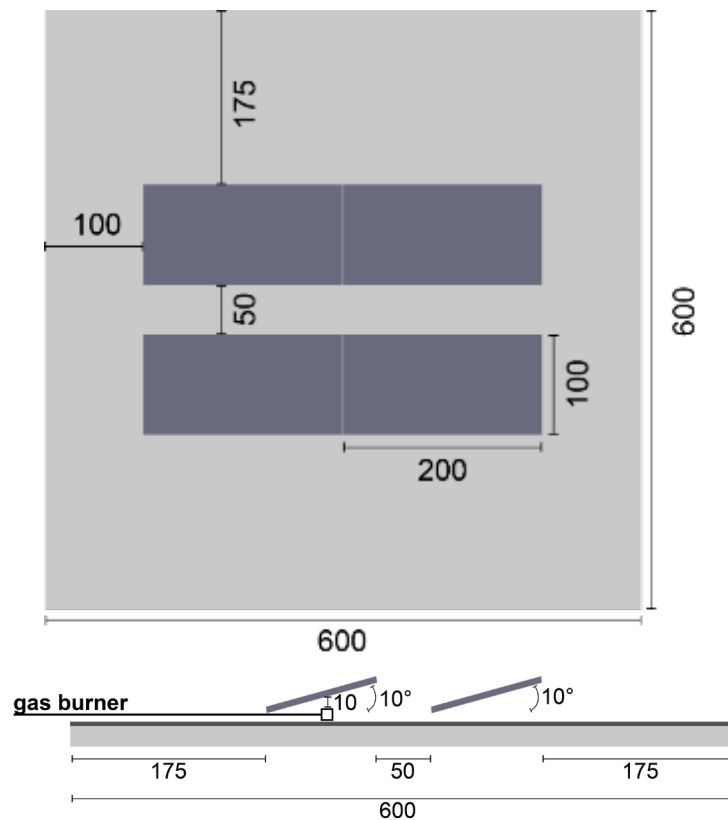
*Test configuration (quote in cm)*

- Two rows of two modules each
- Spaced 50 cm apart
- Distance from the perimeter of the samples: 1 m laterally and 1.75 m vertically (see diagram).

The PV panels were installed with an inclination of 10° relative to the roof, with a minimum gap between the roof and the panel of 100 mm and a maximum gap of about 280 mm.

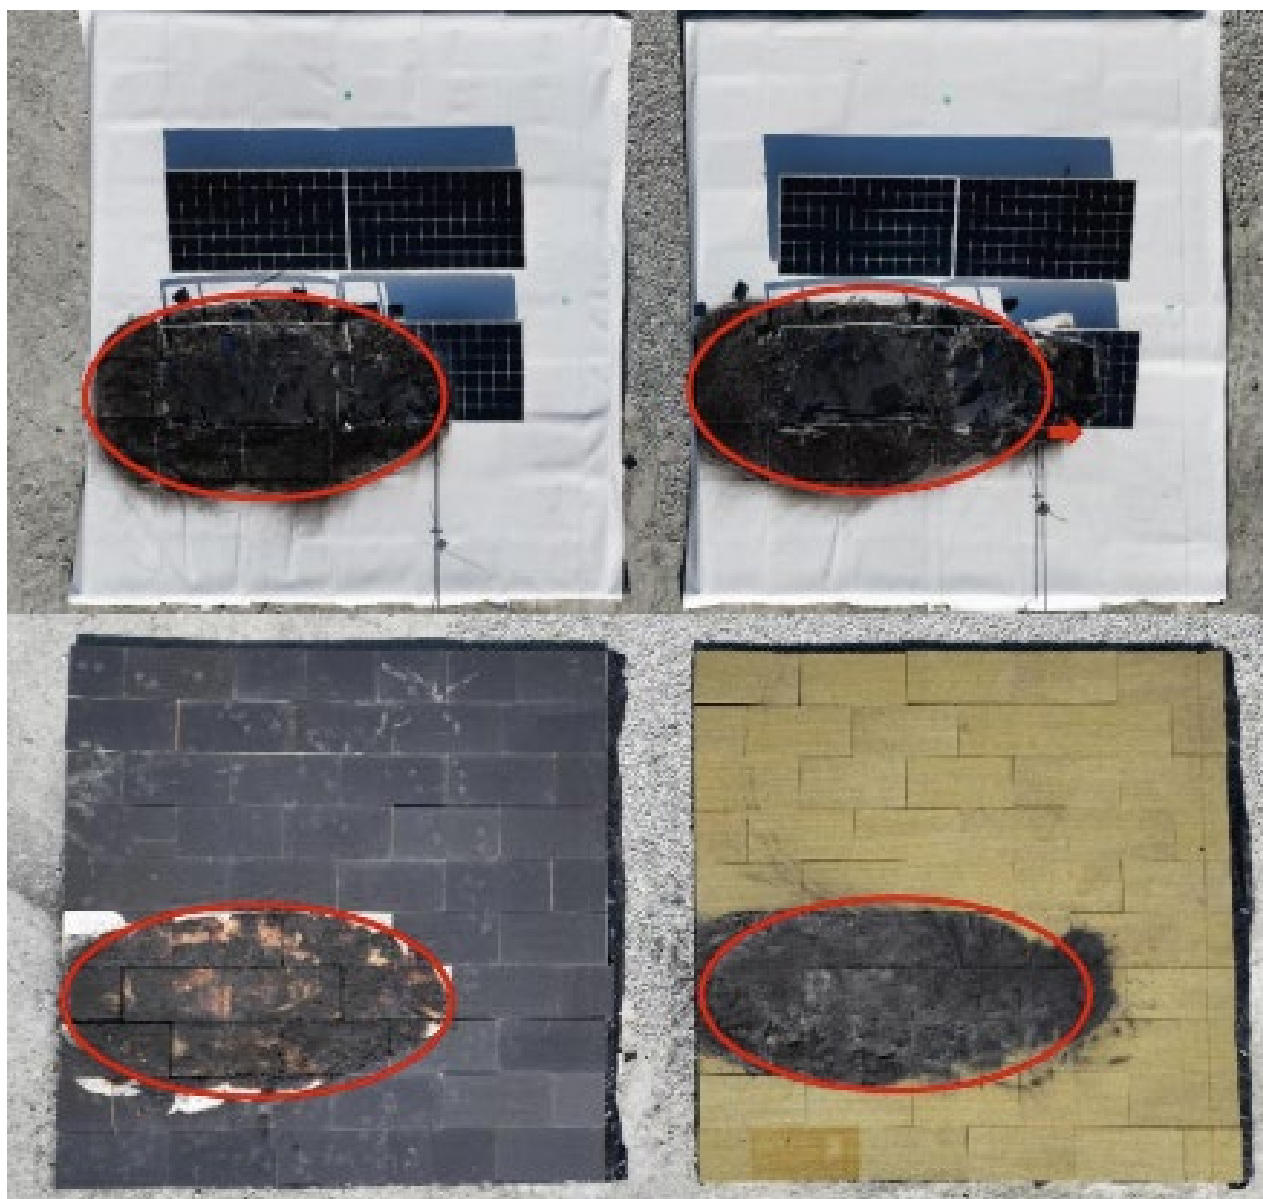
*Damaged areas*

- The size of the damaged area was similar on both types of insulation.
- However, in terms of depth, greater penetration was observed in the MW Rock insulation.
- From a purely visual perspective:
  - The damaged thickness in PU measured approximately 4-5 cm.
  - The damaged thickness in MW Rock measured about 8-9 cm.
